APEX INSIGHT RESIDENTIAL INSPECTION REPORT

1415 Stonegate Rd
Algonquin, IL 60102

01/26/2026

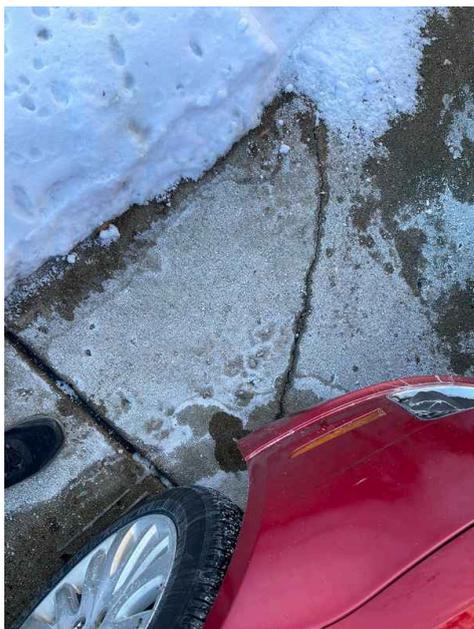
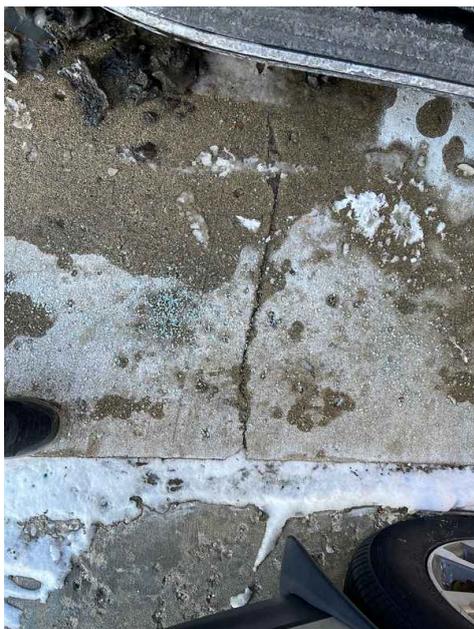
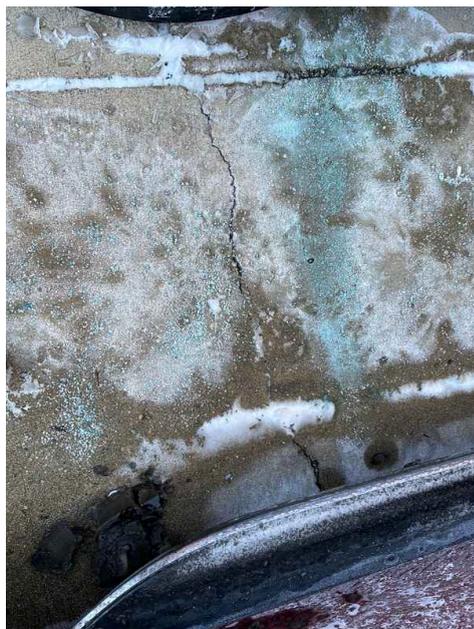
DRIVEWAY CRACKING - MINOR

Minor cosmetic cracks observed, which may indicate movement in the soil. Recommend monitor and/or have driveway contractor patch/seal.

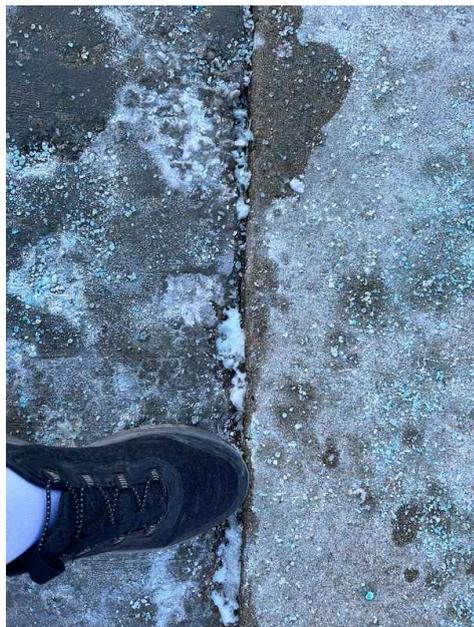
2.2.2 Walkways, Patios & Driveways

DRIVEWAY TRIP HAZARD

Trip hazards observed. Patch or repair recommended.

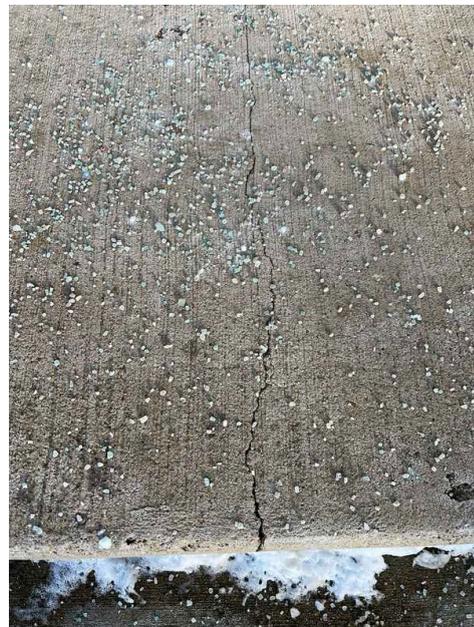
2.2.3 Walkways, Patios & Driveways

PORCH CRACKING - MINOR

Normal settling & cracking observed. Recommend monitor and/or patch/seal.

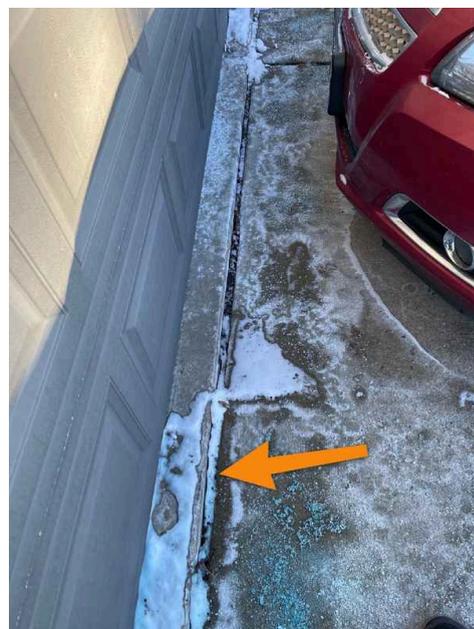
2.2.4 Walkways, Patios & Driveways

EXPANSION JOINT NOT SEALED

Expansion joint needs to be sealed. Can cause water damage

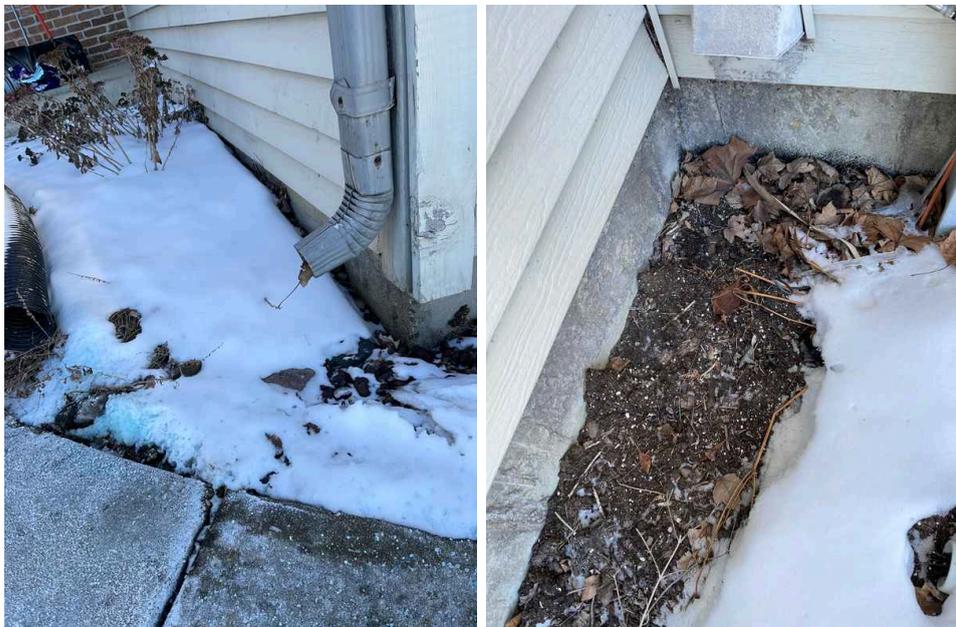
2.3.1 Vegetation, Grading, Drainage & Retaining Walls

NEGATIVE GRADING

Grading is sloping towards the home in some areas. This could lead to water intrusion and foundation issues. Recommend qualified landscaper or foundation contractor regrade so water flows away from home.

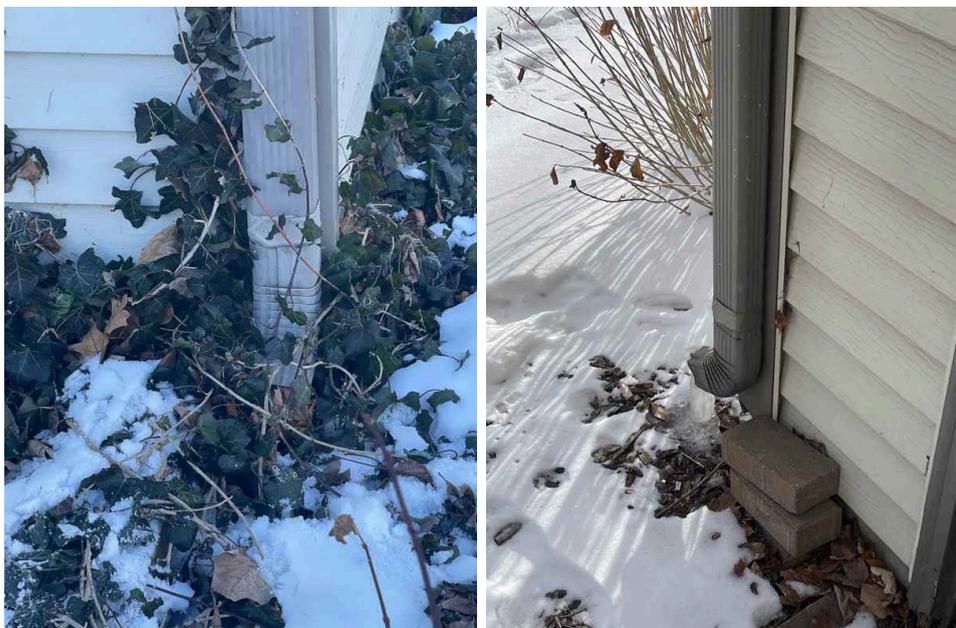
2.3.2 Vegetation, Grading, Drainage & Retaining Walls

GUTTER DOWNSPOUT NEEDS EXTENSION

One or more downspouts discharge too close to the foundation and lack proper extensions. This condition can contribute to moisture intrusion and foundation issues. Recommend adding downspout extensions to direct water away from the structure.

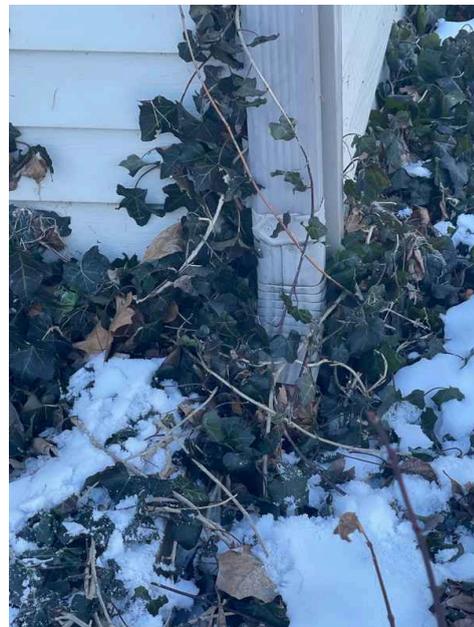
2.3.3 Vegetation, Grading, Drainage & Retaining Walls

VINES COVERING EXTERIOR WALL OR SIDING

Vines and climbing vegetation were observed covering portions of the exterior siding. Vegetation in direct contact with siding can trap moisture, conceal damage, and contribute to deterioration and pest activity. Recommend removing the vines and maintaining clear separation between vegetation and the exterior wall surfaces.

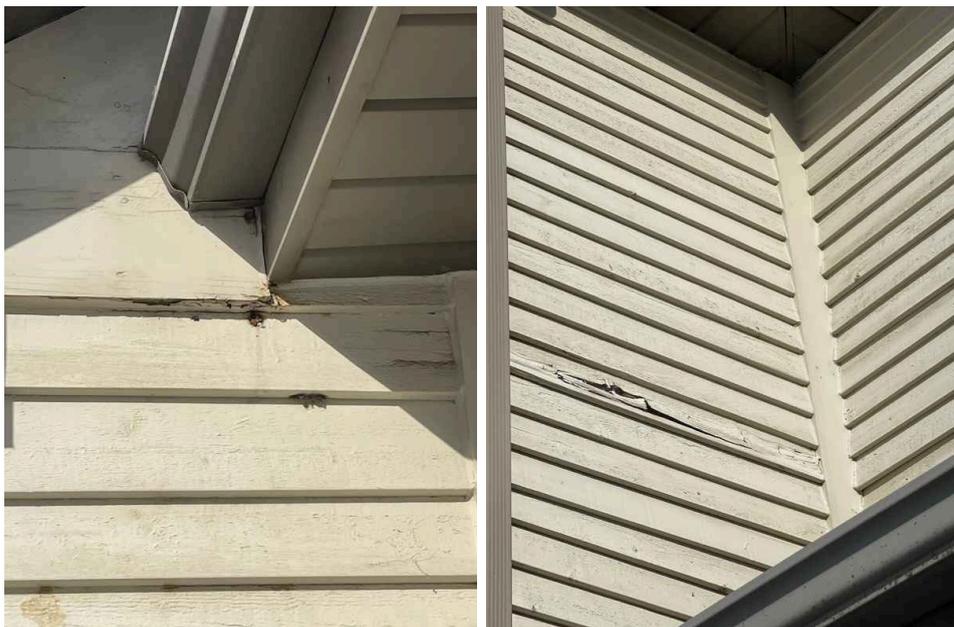
2.4.1 Siding, Flashing & Trim

CRACKING - MINOR

Siding showed cracking in one or more places. This is a result of temperature changes, and typical as homes with stucco age. Recommend monitoring.

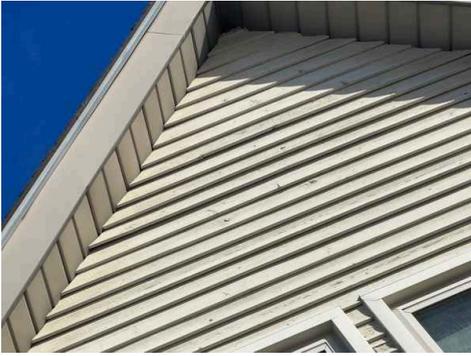
2.4.2 Siding, Flashing & Trim

LOOSE BOARDS

One or more siding boards were loose, which could result in moisture intrusion. Recommend a qualified siding contractor secure and fasten.

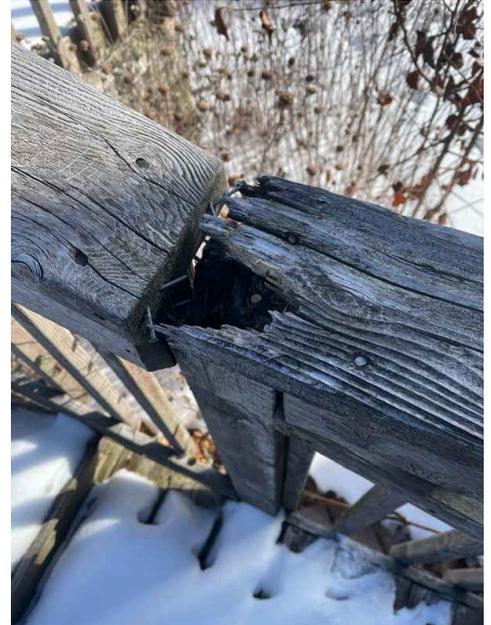
2.5.1 Decks, Balconies, Porches & Steps

DECK - ROTTED BOARDS

One or more deck boards are showing signs of rot. Recommend a qualified deck contractor replace.

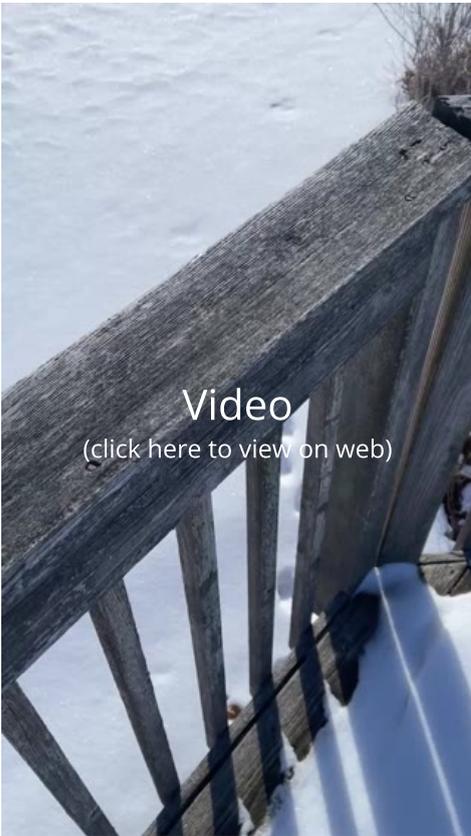
2.5.2 Decks, Balconies, Porches & Steps

DECK - UNSTABLE SUPPORT

One of more areas of the deck support appears unstable. This could cause a safety hazard and further deterioration of the deck. Recommend qualified deck contractor evaluate and repair.

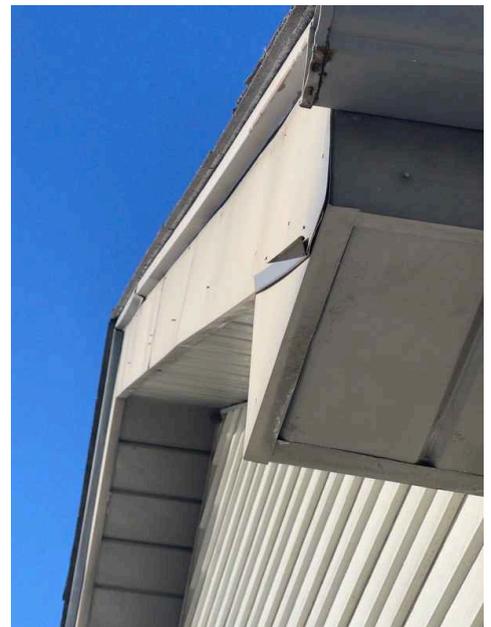
2.6.1 Eaves, Soffits & Fascia

FASCIA - LOOSE

One or more sections of the fascia are loose. Recommend qualified roofer evaluate & repair.

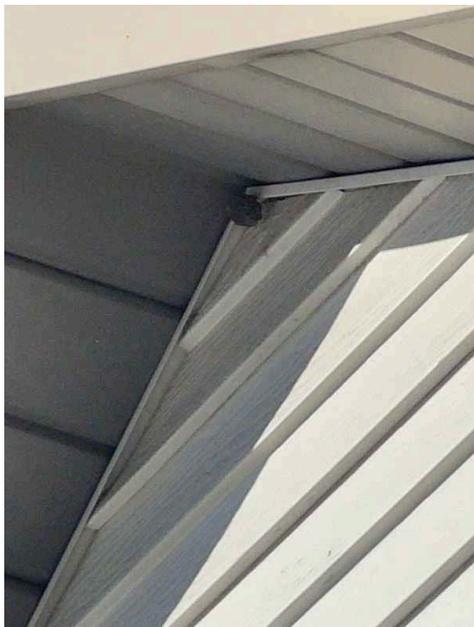
2.6.2 Eaves, Soffits & Fascia

WASPS NEST

Wasp nests were visible under the soffits. Recommend a qualified exterminator evaluate and remove.

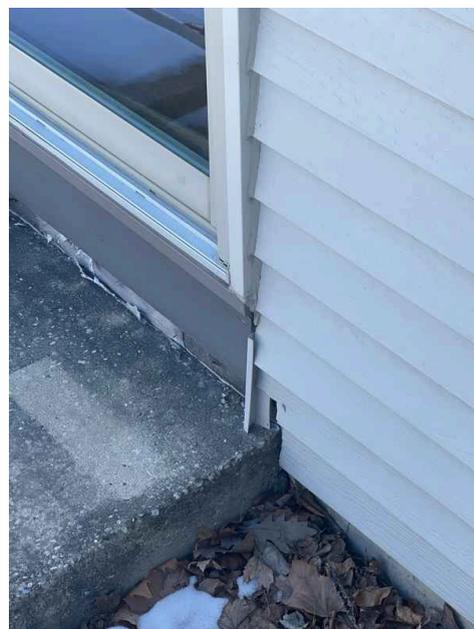
2.7.1 Window's Exterior

IMPROPER OR INCOMPLETE TRIM/FLASHING AT EXTERIOR OF THE SLIDING DOOR

Improper detailing was observed at the lower exterior corner of the sliding door. The trim/flashings is incomplete and a visible gap is present between the door frame and the siding/foundation. This condition can allow water intrusion and may lead to hidden moisture damage. Recommend sealing and proper repair by a qualified contractor.

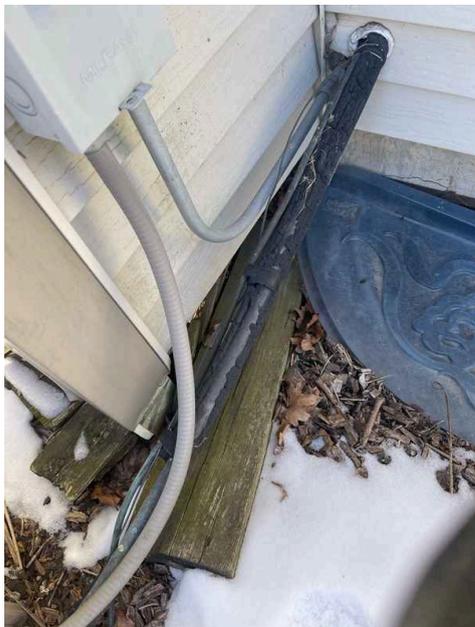
2.8.1 Cooling Equipment

INSULATION MISSING OR DAMAGED

Missing or damaged insulation on refrigerant line can cause energy loss and condensation.

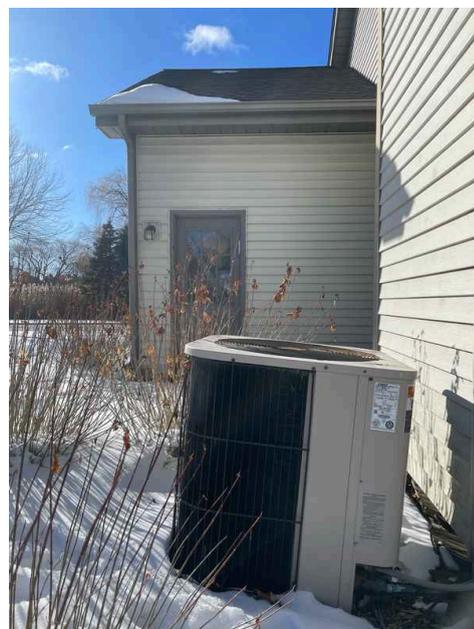
2.8.2 Cooling Equipment

UNIT NOT LEVEL

Concrete pad supporting the outdoor condensing unit is not level. This can cause accelerated deterioration of components. Recommend licensed HVAC contractor level the unit.

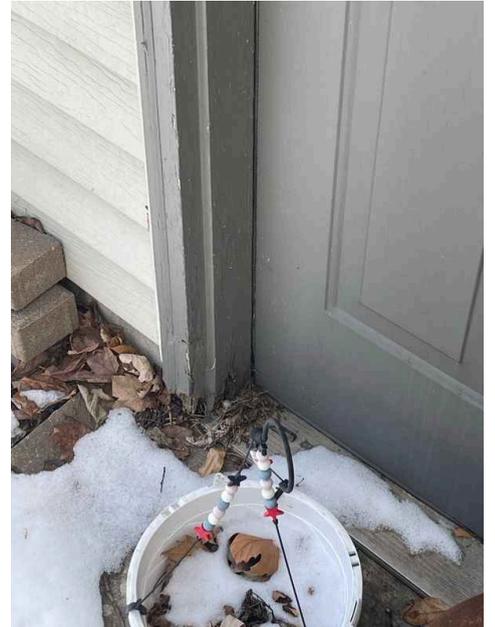
DAMAGE OR DETERIORATING DOOR

Exterior garage door jamb deterioration

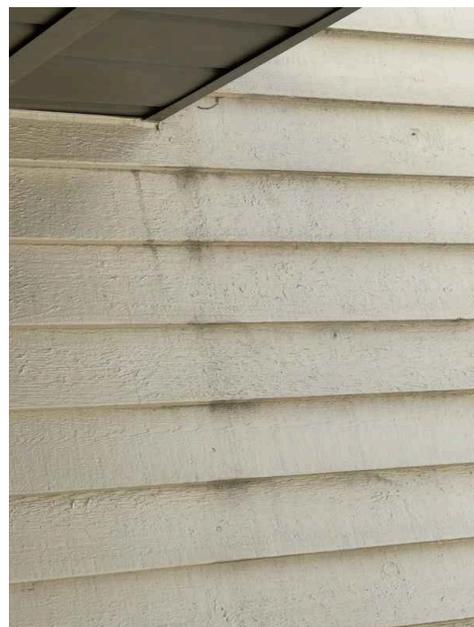
GUTTER LEAKAGE

Gutters were observed to be leaking in one or more areas. This can result in excessive moisture in the soil at the foundation, which can lead to foundation/structural movement. Recommend a qualified contractor evaluate and repair gutters to proper functionality.

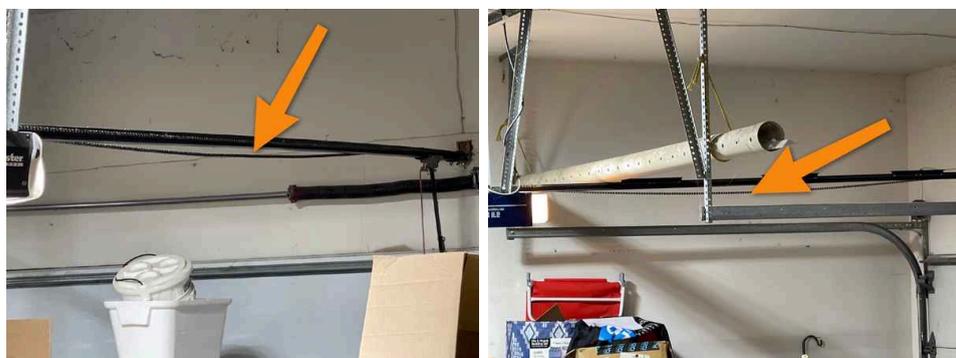
Recommendation**GARAGE DOOR OPENER CHAIN LOOSE**

The garage door opener drive chain was observed to be loose and sagging along the rail. A loose chain can cause improper operation, excessive noise, and accelerated wear on the opener components. Adjustment of the chain tension in accordance with the manufacturer's specifications is recommended. Further evaluation and repair by a qualified garage door service technician is advised.

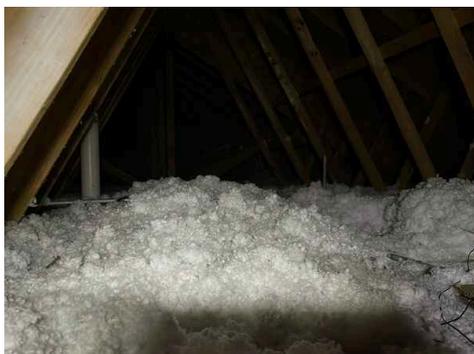
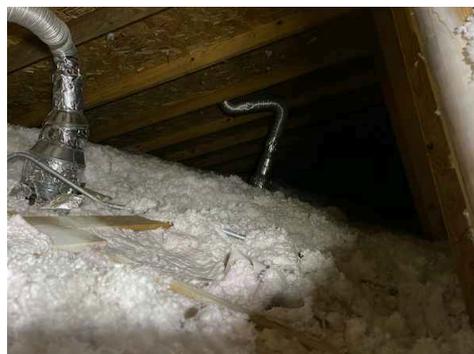
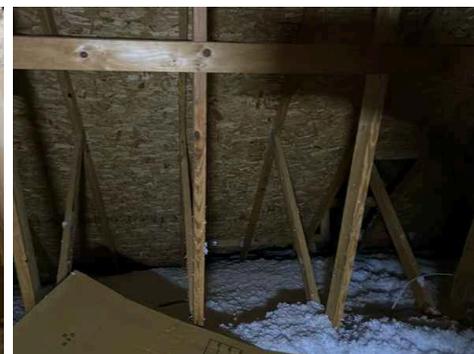
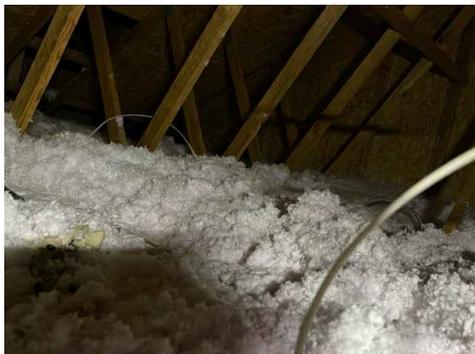
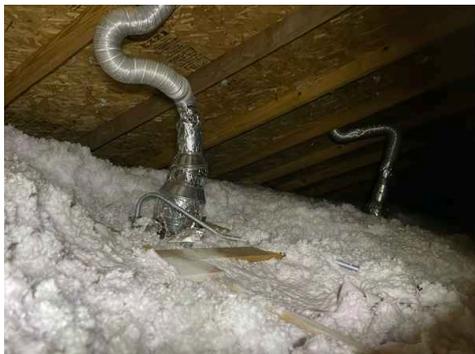
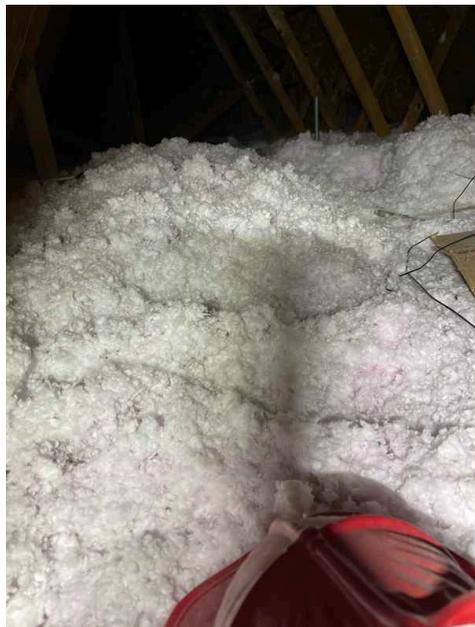
Insulation depth was inadequate. Recommend a qualified attic insulation contractor install additional insulation.

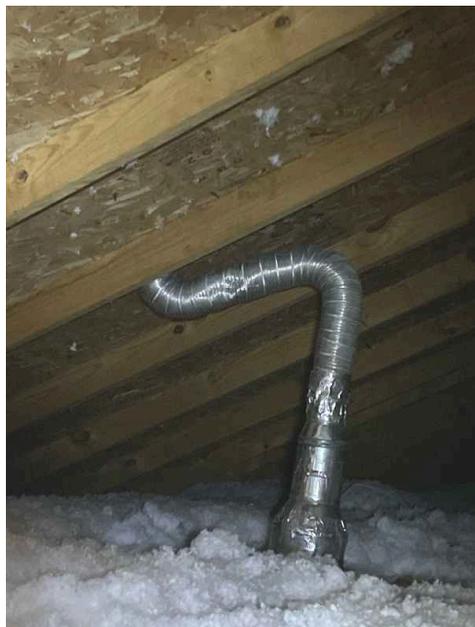
5.5.1 Exhaust Systems

BATHROOM EXHAUST DUCT IMPROPERLY INSTALLED

The bathroom exhaust duct observed in the attic was constructed using flexible foil ducting with excessive bends and lacked insulation. This type of installation can restrict airflow and promote condensation in cold climates, increasing the risk of moisture damage and mold growth. Recommend correction by installing a properly sized, insulated, and rigid or semi-rigid duct vented directly to the exterior in accordance with current standards.

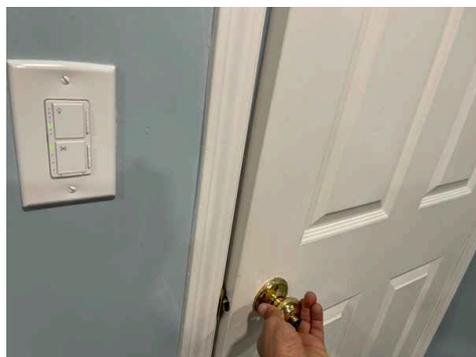
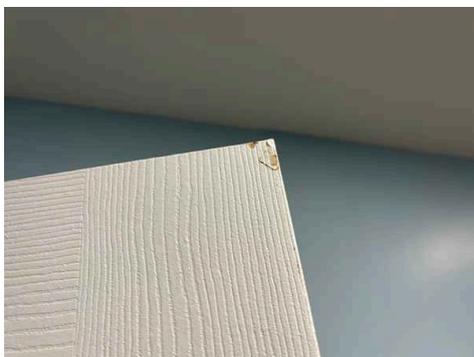
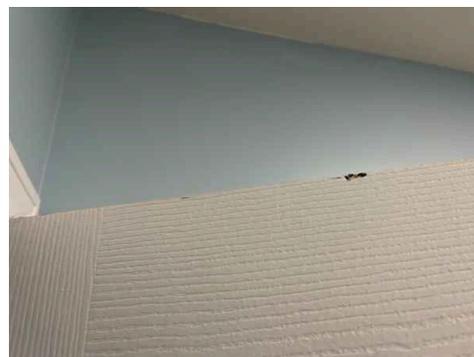
Door doesn't latch properly. Recommend handyman repair latch and/or strike plate.

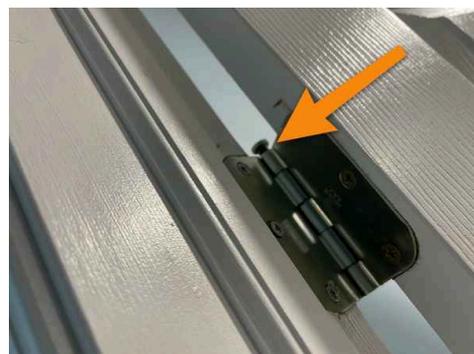
6.1.2 Doors

DOOR STICKS

Door sticks and is tough to open. Recommend sanding down offending sides.

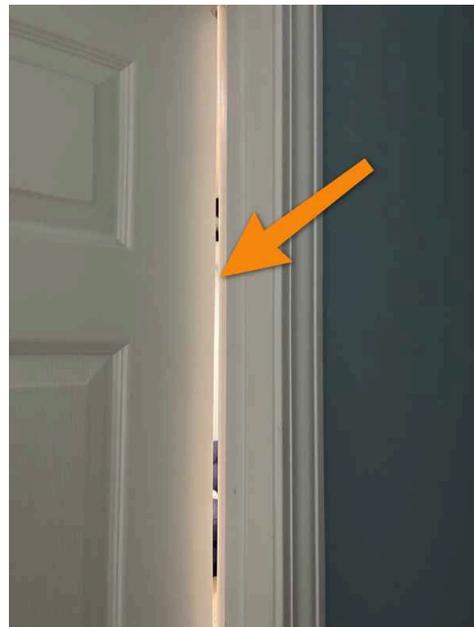
6.1.3 Doors

One or more gaps could result in energy loss. Recommend handyman or door contractor evaluate.

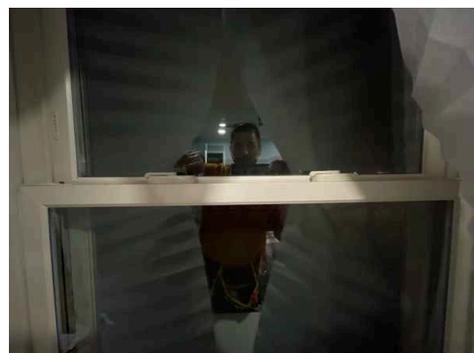
6.2.1 Windows

AIR LEAKAGE AT DOUBLE-HUNG WINDOW (SASH OVERLAP)

Minor air leakage was observed at the sash overlap of a double-hung window. This is commonly associated with aging or compressed weatherstripping. Sealing improvements are recommended to reduce drafts and improve energy efficiency

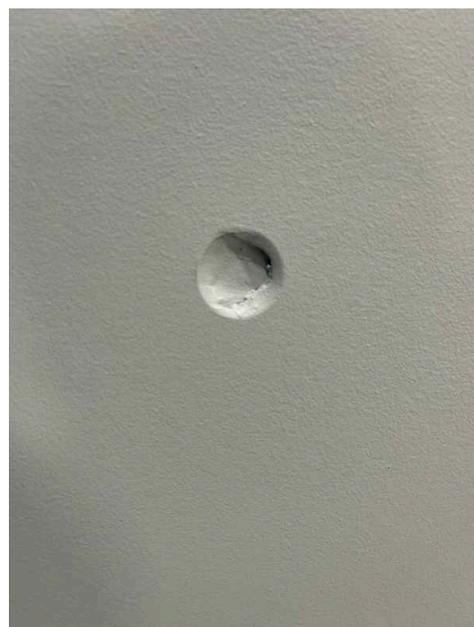
6.4.1 Walls

DOORKNOB HOLE

Wall had damage from doorknob. Possibly due to lack of door stopper. Recommend a qualified handyman or drywall contractor repair.

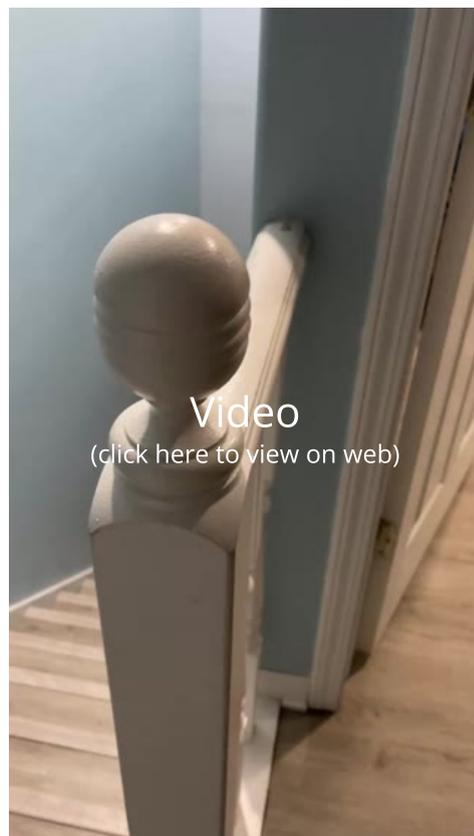
6.6.1 Steps, Stairways & Railings

LOOSE GUARDRAIL

The guardrail was noted to have some movement when pressure was applied. While functional at the time of inspection, it should be secured to improve stability and safety. Recommend evaluation and repair as needed by a qualified contractor.

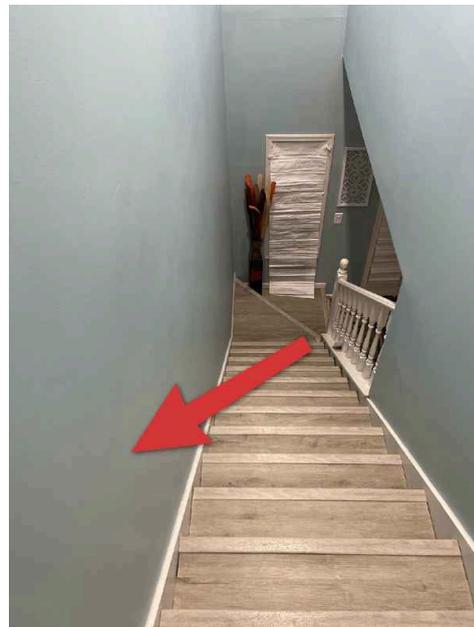
6.6.2 Steps, Stairways & Railings

HANDRAIL INADEQUATE AT STAIRWAY

The stairway was observed to lack a proper graspable handrail for safe use while ascending and descending the stairs. A compliant handrail is recommended to improve safety and reduce the risk of falls. Recommend installation or correction by a qualified contractor.

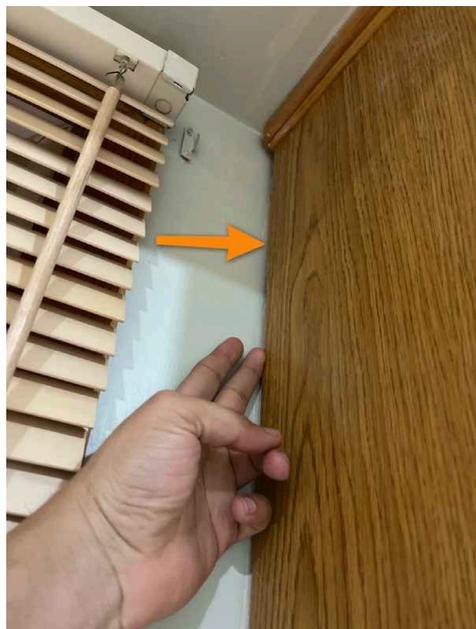
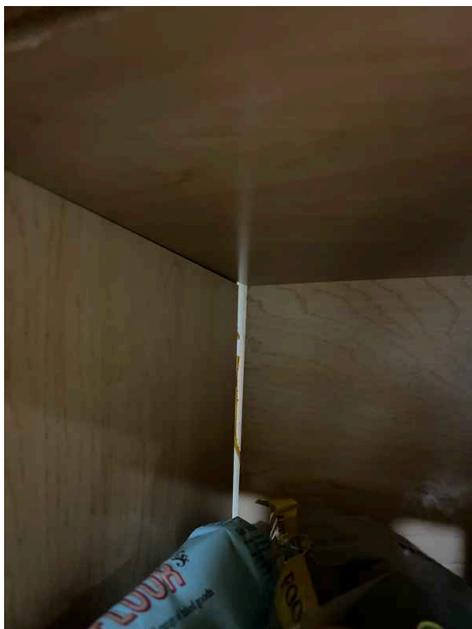
6.7.1 Countertops & Cabinets

CABINET SEPARATING FROM WALL

Cabinets are separating from ceiling or wall. Recommend a qualified cabinet contractor re-fasten cabinets securely.

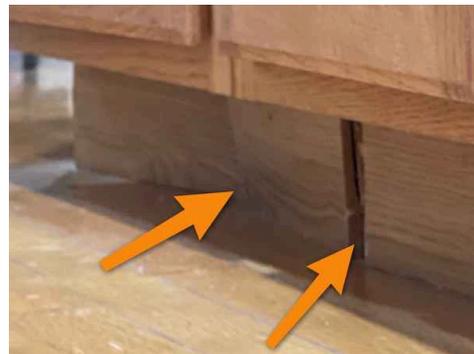
6.7.2 Countertops & Cabinets

CRACKED AND GAP AT KITCHEN ISLAND BASE

A visible crack/broken and gap was noted at the base of the kitchen island. Repair or cosmetic correction is recommended for improved finish and durability.

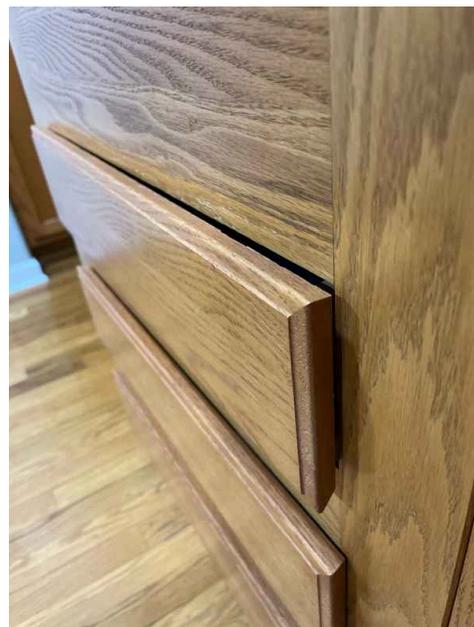
6.7.3 Countertops & Cabinets

KITCHEN DRAWER OUT OF ALIGNMENT

One or more kitchen drawers were observed to be misaligned and not closing flush with the surrounding cabinetry. This condition may indicate worn or improperly adjusted drawer hardware and can affect proper operation and appearance. Recommend adjustment or repair by a qualified contractor or cabinet specialist.

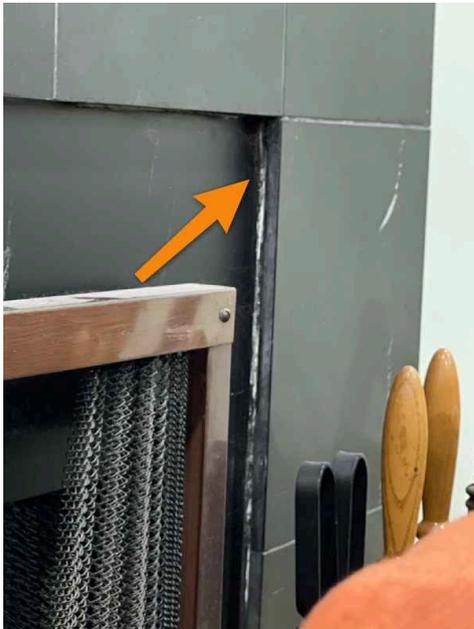
7.5.1 Fireplaces - Common Deficiencies

A visible gap was observed between the fireplace box and the surrounding tile finish. This joint should be sealed with an appropriate non-combustible, heat-resistant sealant to prevent heat or byproducts of combustion from entering surrounding wall cavities. Recommend sealing with a fireplace-rated material by a qualified contractor prior to use.

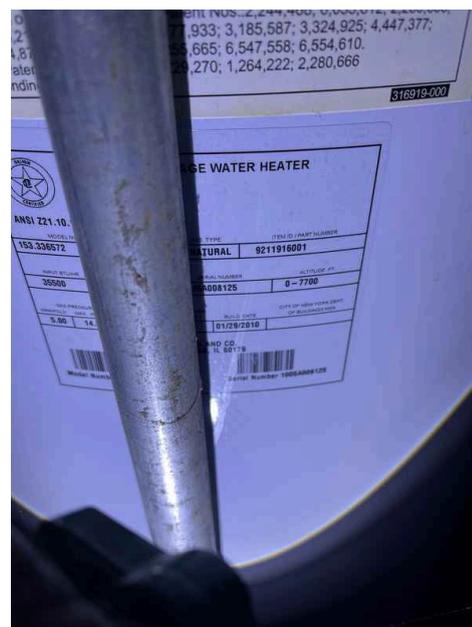
NEAR END OF LIFE

Water heater showed normal signs of wear and tear. Recommend monitoring it's effectiveness and replacing in the near future.

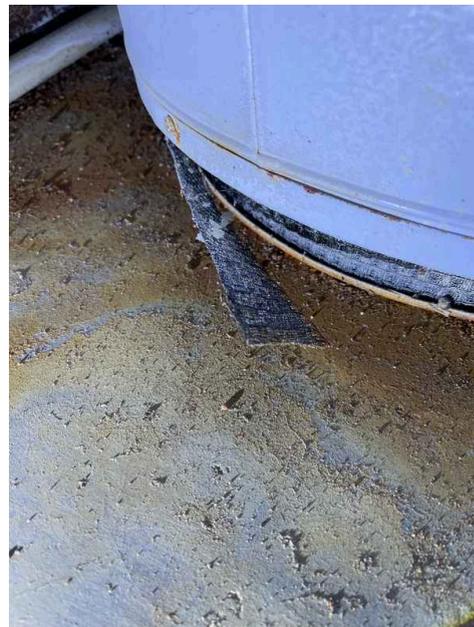
9.4.2 Hot Water Systems, Controls, Flues & Vents

WATER HEATER INSULATION JACKET DETERIORATION

Insulation backing material was observed protruding from the bottom of the water heater. This appears to be part of the tank's insulation jacket. No active leakage was observed at the time of inspection. Recommend monitoring and trimming or repairing the jacket as needed.

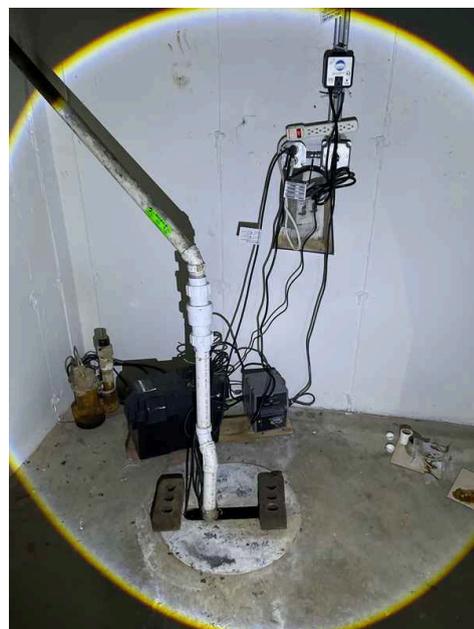
9.6.1 Sump Pump

IMPROPER ELECTRICAL CONNECTIONS AT SUMP PUMP

The sump pump and related equipment were observed plugged into a power strip and multiple adapters near the sump pit. Power strips are not intended for permanent use or damp locations and may increase the risk of electrical failure or accidental disconnection during operation. A dedicated GFCI-protected receptacle is recommended for each pump. Correction by a qualified electrician is advised.

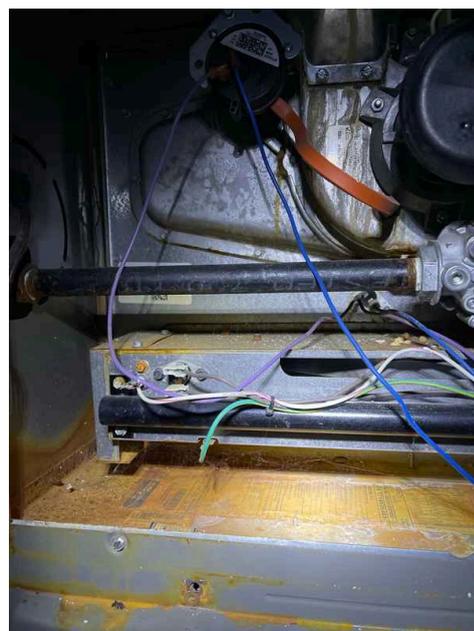
CORROSION

Furnace was corroded in one or more areas. This could be the result of improper venting, which the source would need to be identified. Recommend a HVAC contractor evaluate and repair.

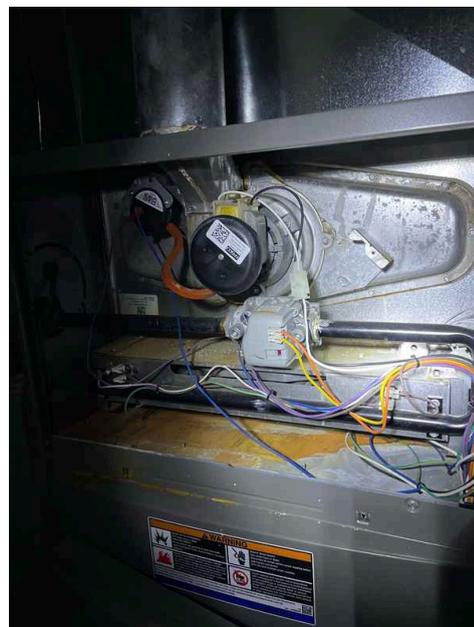
11.1.2 Equipment

Furnace should be cleaned and serviced annually. Recommend a qualified HVAC contractor clean, service and certify furnace.

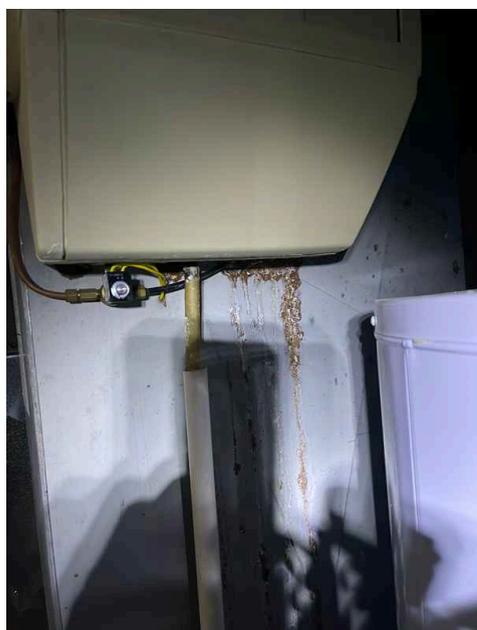
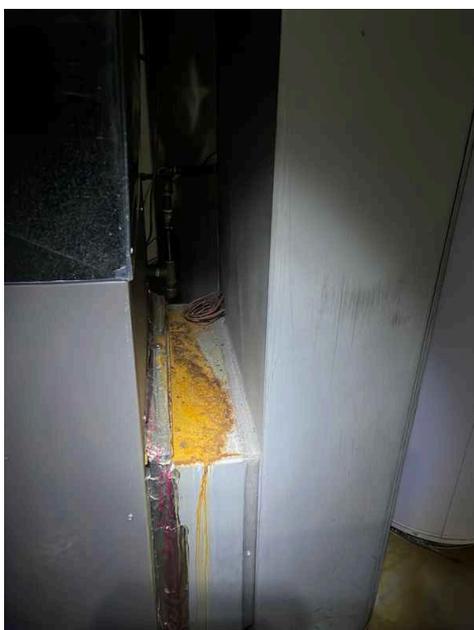
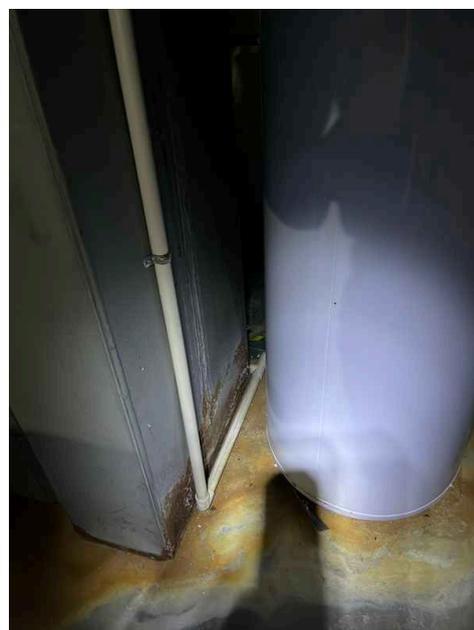
11.1.3 Equipment

HUMIDIFIER LEAKING

The whole-house humidifier was observed leaking water at the unit and/or associated piping connections. Water staining and mineral deposits were present on the adjacent ductwork, indicating ongoing leakage. Continued leakage can lead to corrosion, mold growth, and damage to HVAC components. Recommend evaluation and repair or replacement by a qualified HVAC technician.

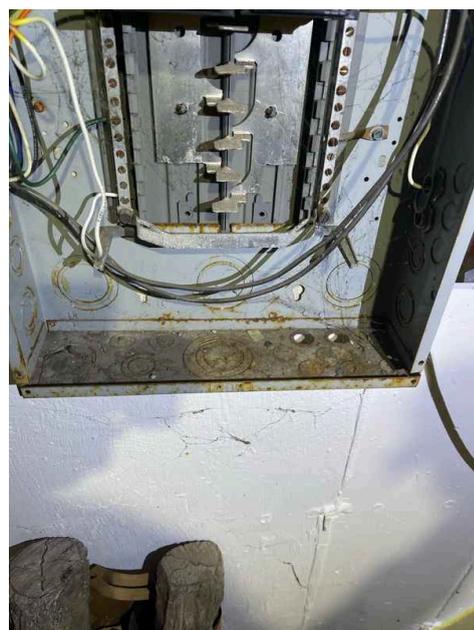
CORROSION IN MAIN OR SUBPANEL

Corrosion and rust were observed inside the electrical panel enclosure. This condition may indicate past moisture intrusion and can lead to deterioration of electrical components. Recommend evaluation and repair by a qualified electrician.

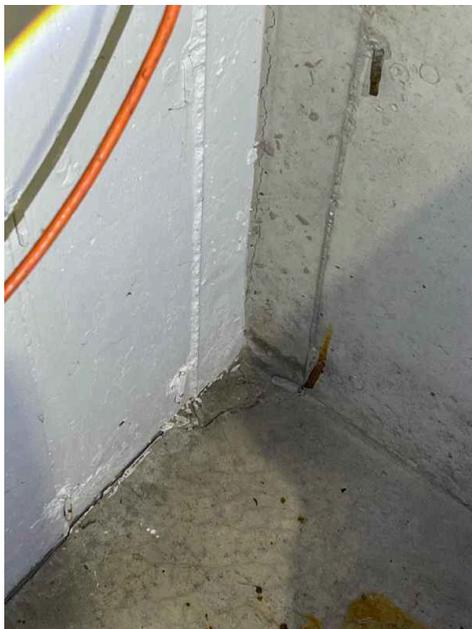
13.1.1 Foundation

FOUNDATION CRACKS - MINOR

Minor cracking was noted at the foundation. This is common as concrete ages and shrinkage surface cracks are normal. Recommend monitoring for more serious shifting/displacement.
